Evaluating the Use of Drones for Timber Bridge Inspection

Junwon Seo
James P. Wacker
Luis Duque

Forest Service
Forest Products Laboratory
General Technical Report
FPL-GTR-258
August 2018

A FHWA-NHCBP (National Historic Covered Bridge Program) publication

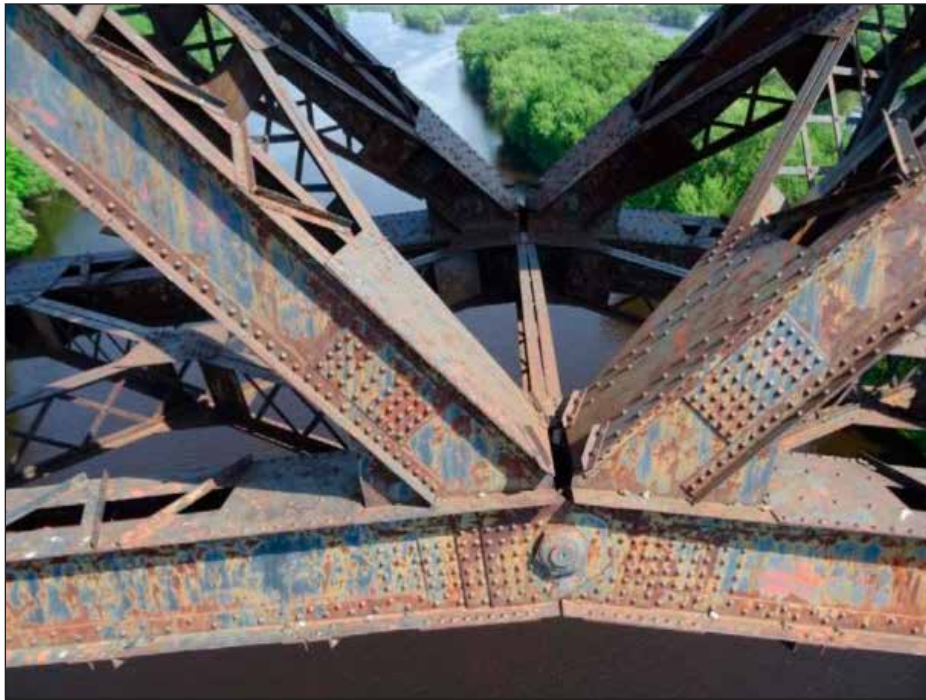
Figure 1. Sample inspection picture taken by the Aeyron Skyranger of a pin connection on a truss bridge (Zink and Lovelace 2015).

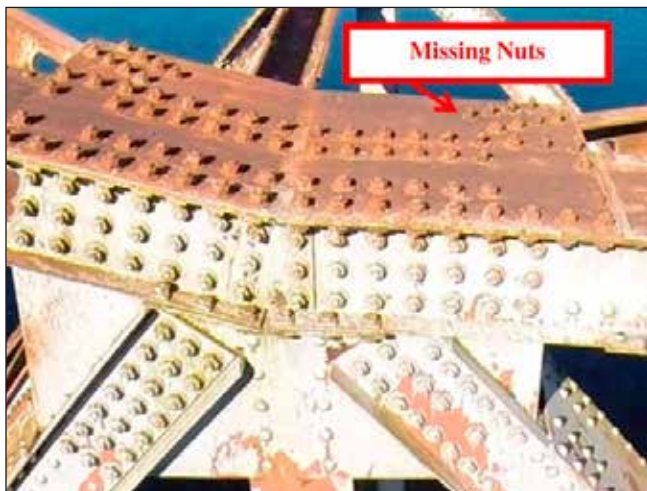
Figure 2. Sample inspection pictures: (a) steel connection with missing nuts; (b) stress crack on timber beam (Otero and others 2015).

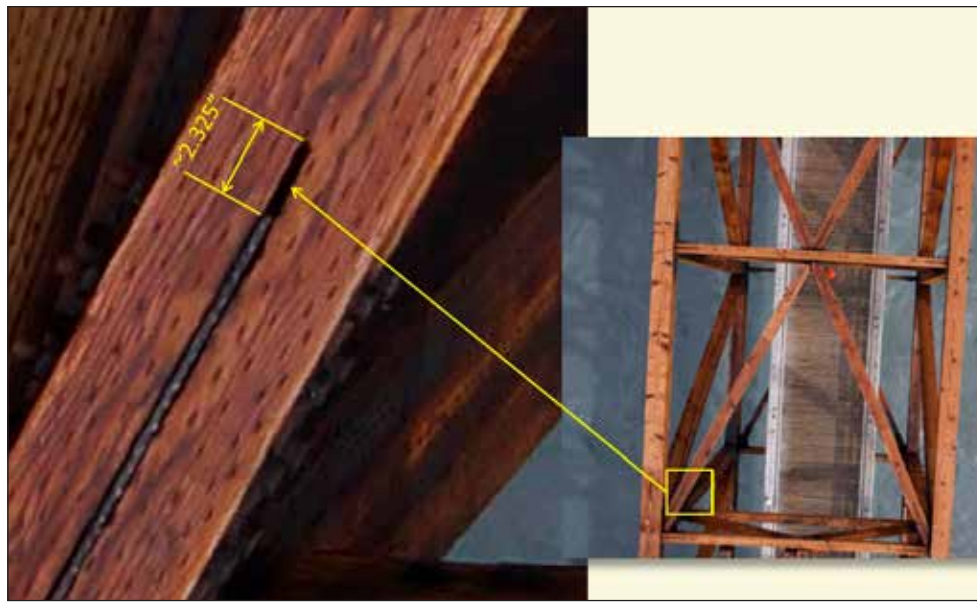
Figure 3. Representative inspection data: (a) gap between end of kerf plate and sawn kerf in brace; (b) 3D dense point cloud representation of the selected bridge using Photoscan (Khaloo and others 2017).

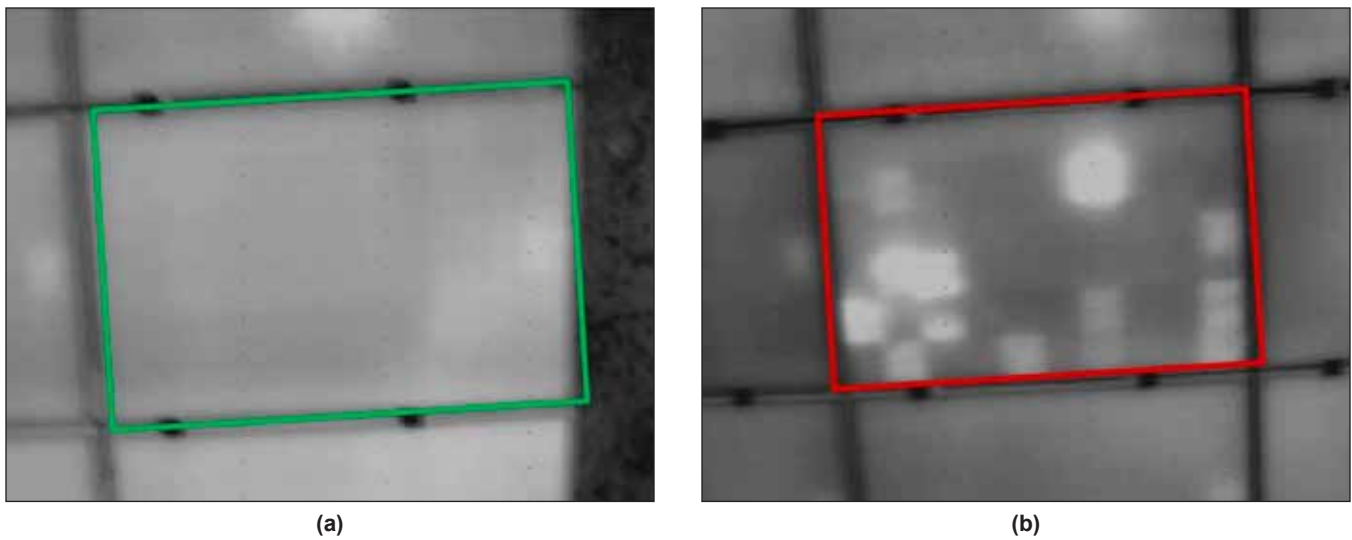
Figure 4. Solar panel inspection using thermal camera: (a) solar panel; (b) defective panel (Aghaei and others 2015).

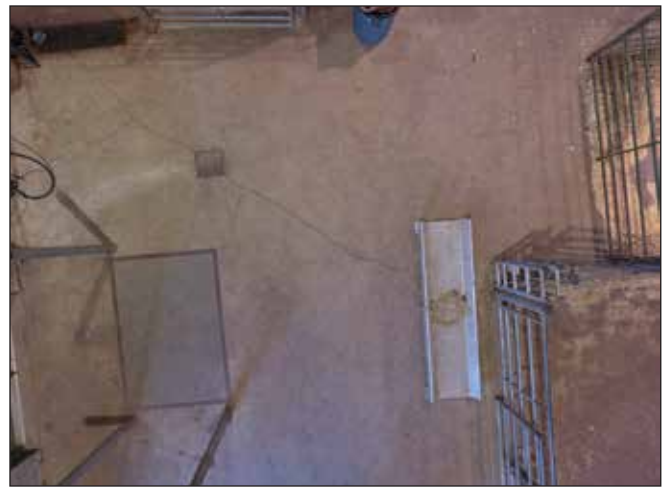
Figure 12. Sample images obtained during inspection of the building using the drone: (a) concrete wall; (b) concrete slab with cracks; (c) tall concrete column (because of underexposure, this image was lightened); (d) short concrete column (because of underexposure, this image was lightened); (e) Luis Duque flying the drone; (f) Junwon Seo flying the drone.

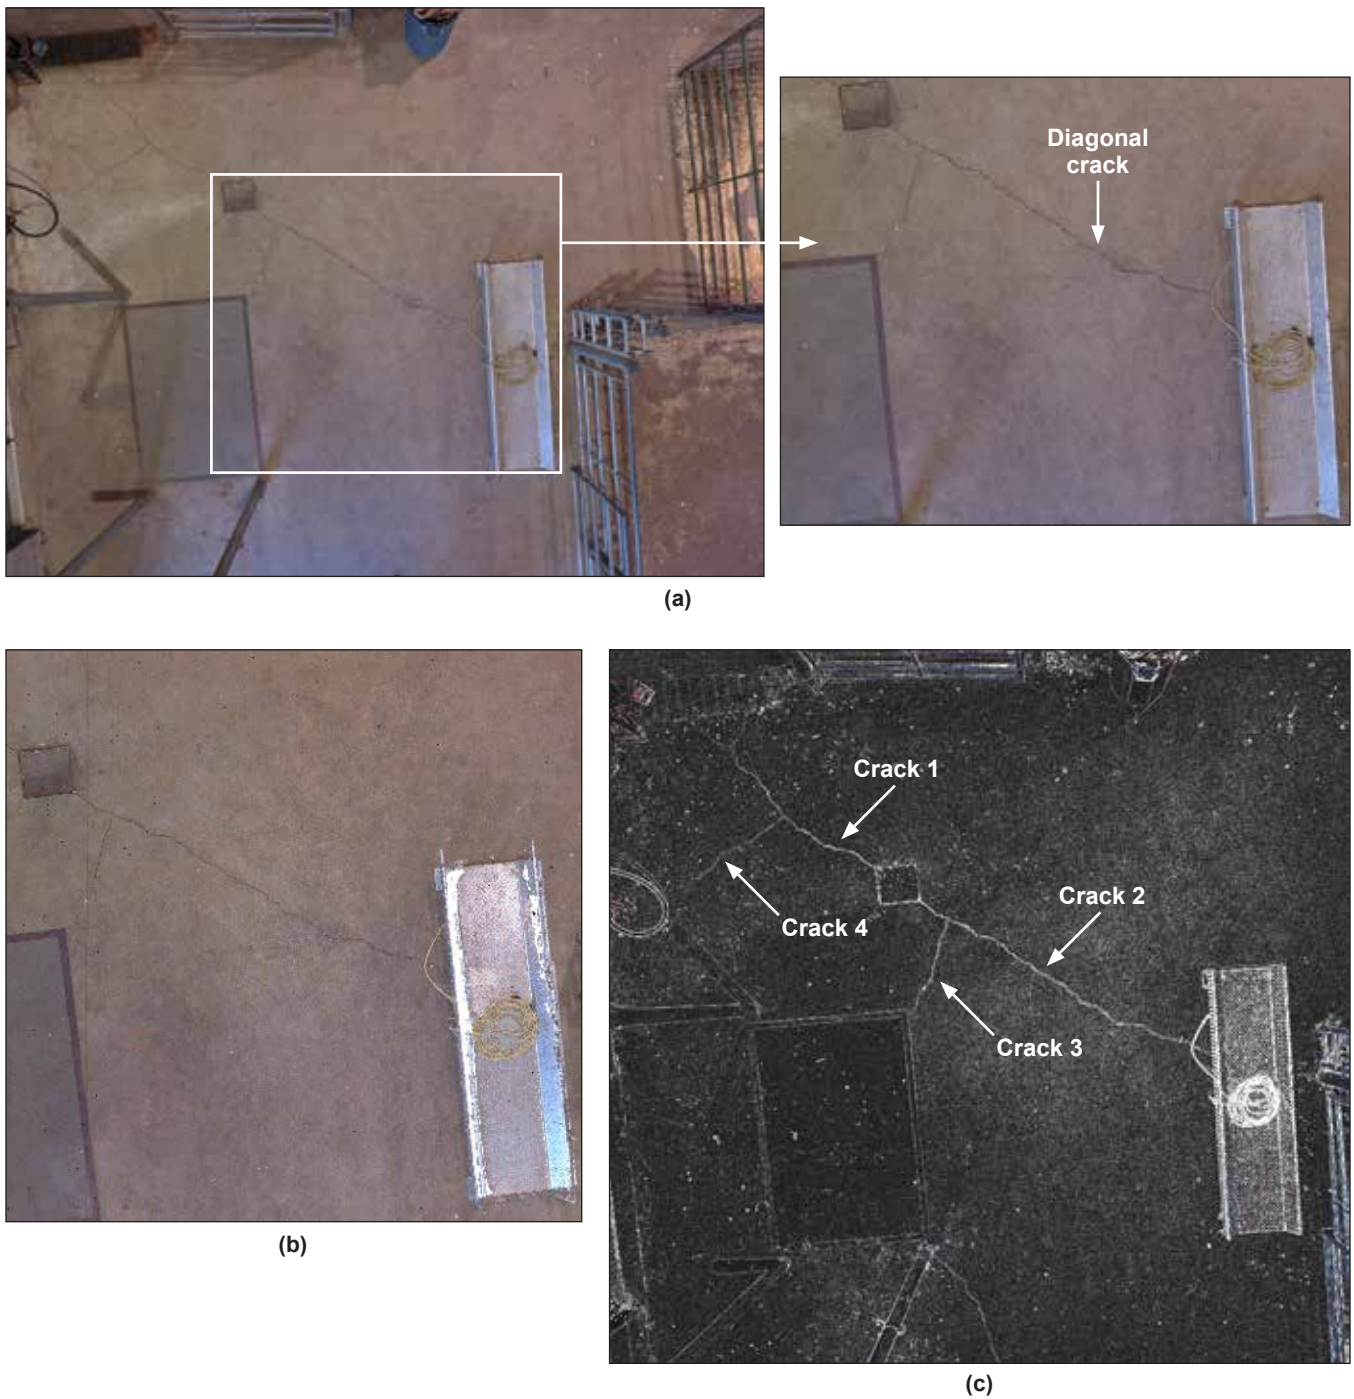
Figure 14. Crack on the slab: (a) images from drone; (b) 3D representation from PhotoScan; (c) processed image for edge detection from ImageJ to better visualize crack (because of underexposure, this image was lightened).

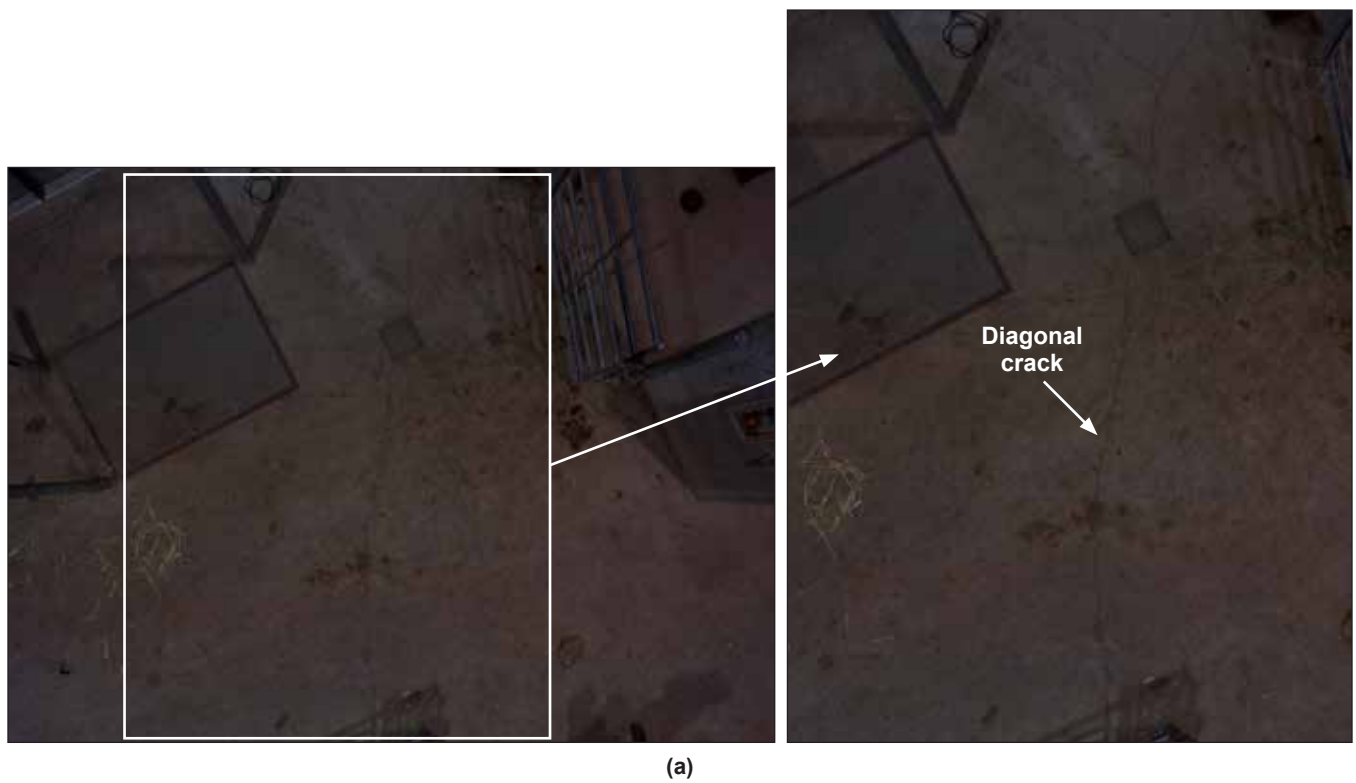
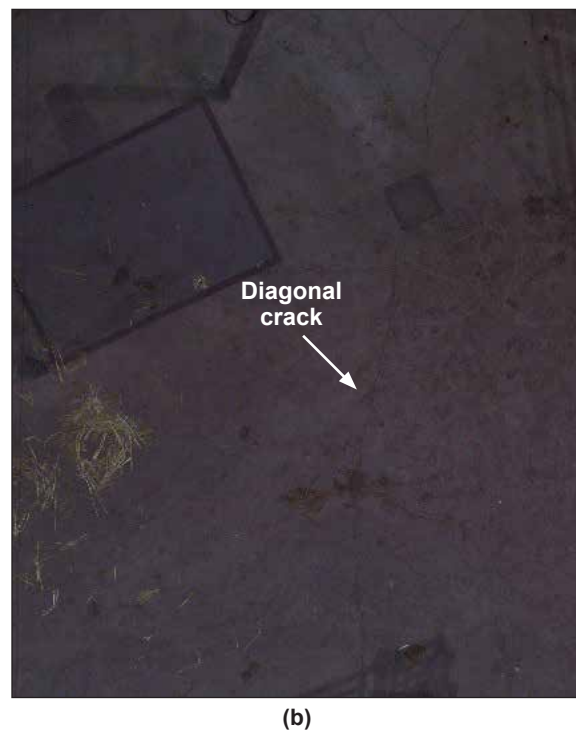
Figure 16. Crack on the slab using low illumination images: (a) image from drone; (b) 3D representation from PhotoScan.

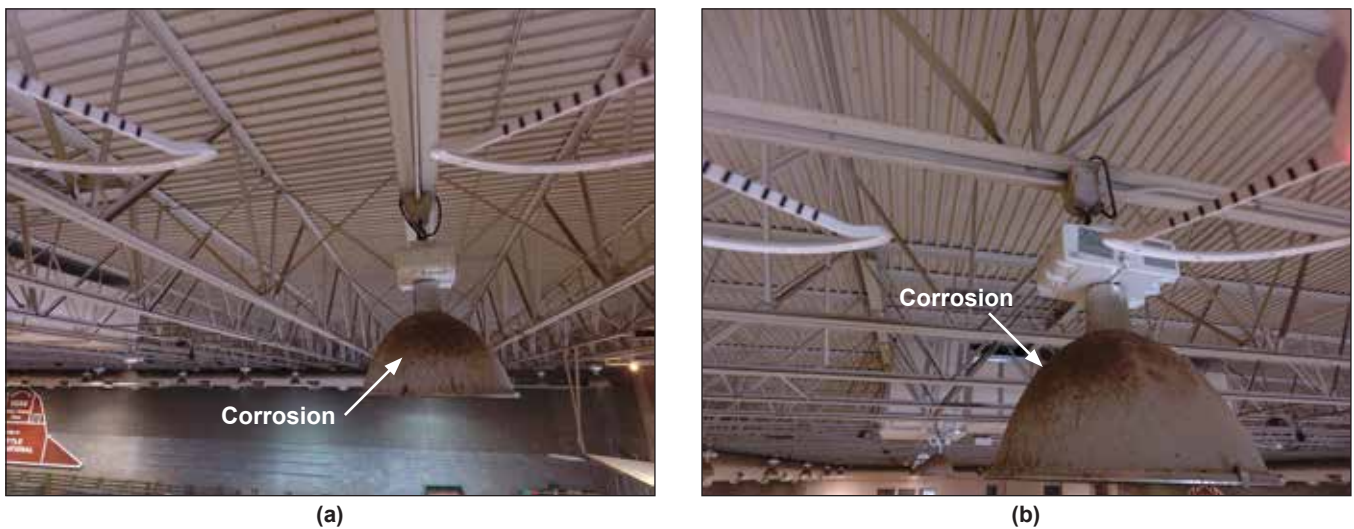
Figure 22. Corroded lamp images taken from different angles using the drone: (a) camera directly pointing at corrosion; (b) camera pointing to the side of the corrosion.

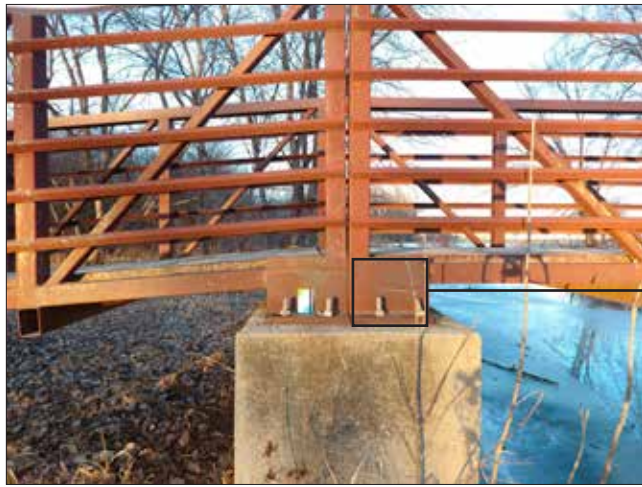
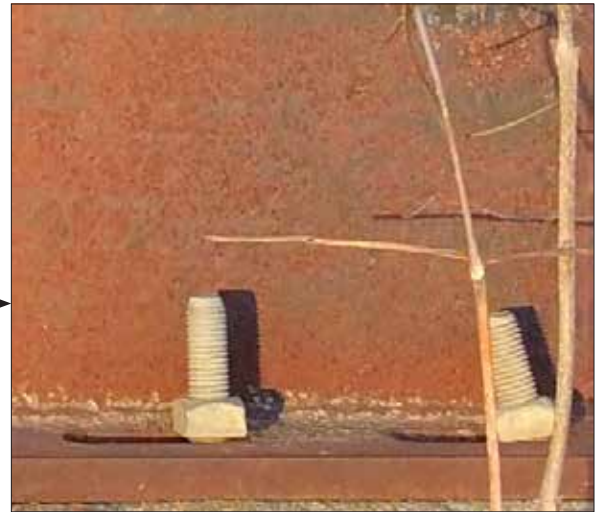
Based upon the observation and 3D virtual re-creation of the high-quality images, several damage types such as corrosion, concrete cracking, and missing bolt nuts were identified. For example, Figure 31a shows a bolt that was bent, and the bolt was represented in 3D virtual space as shown in Figure 31b. The drone hovered at a distance of about 2 ft from the surface of the bridge and identified missing bolt nuts (Fig. 31c). Corrosion was also identified on most railings and on some lateral bracings and stringers (Fig. 31d). Overall, the bridge presented several timber board separations and holes on the deck (Fig. 31e) and some concrete cracking at the abutment (Fig. 31f). A summary of the image-based and field measurements for the bent bolt, deck hole diameter, and crack length is presented in Table 9. Most of the images obtained were of high quality and enabled the identification of different damage types on the bridge components. Any damage rating information specific to the aforementioned damage was not specified in the Caltrans bridge rating manual (Marshall 2016).

Figure 31. Damage detected using the drone during the outdoor flight: (a) bended bolt; (b) 3D virtual representation of bended bolt; (c) missing bolt nuts; (d) steel truss member corrosion; (Figure 31 continued next page)

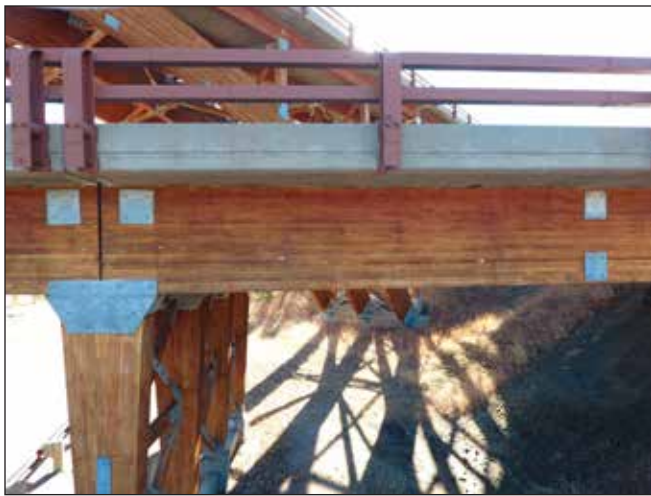
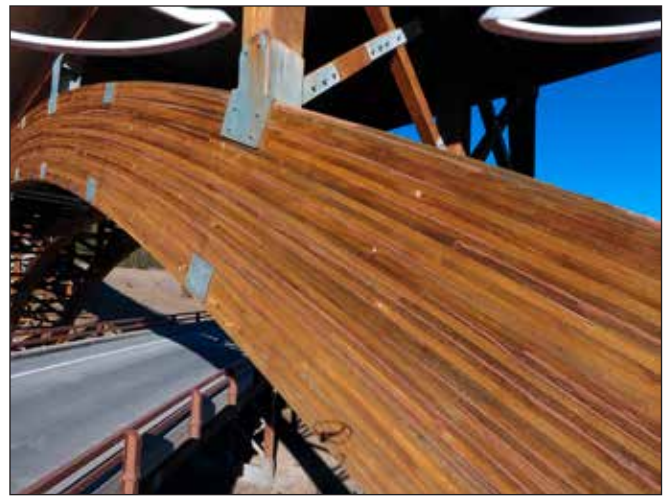
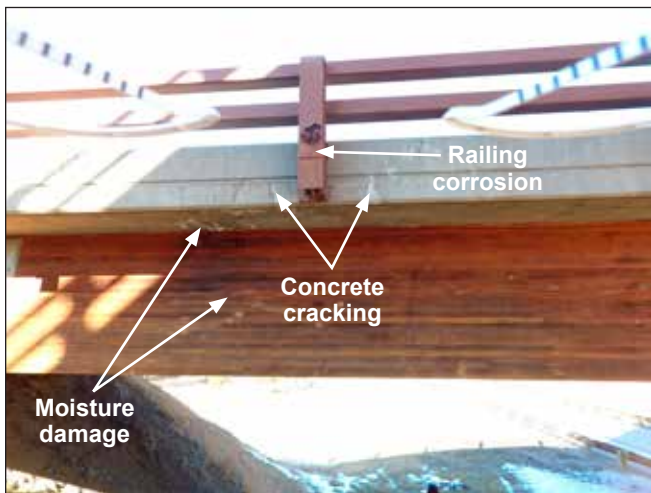
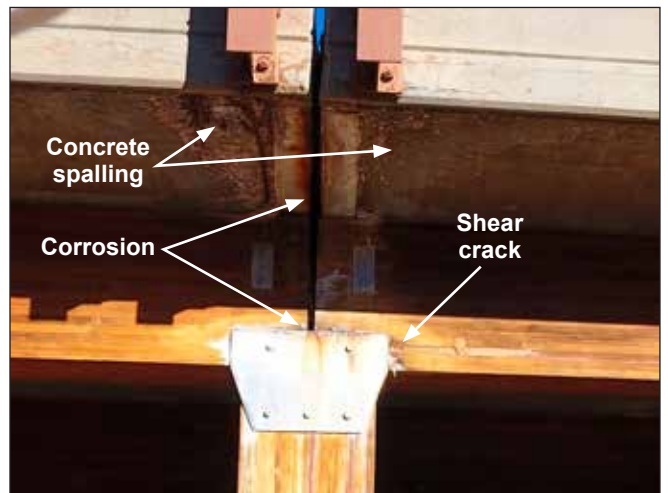
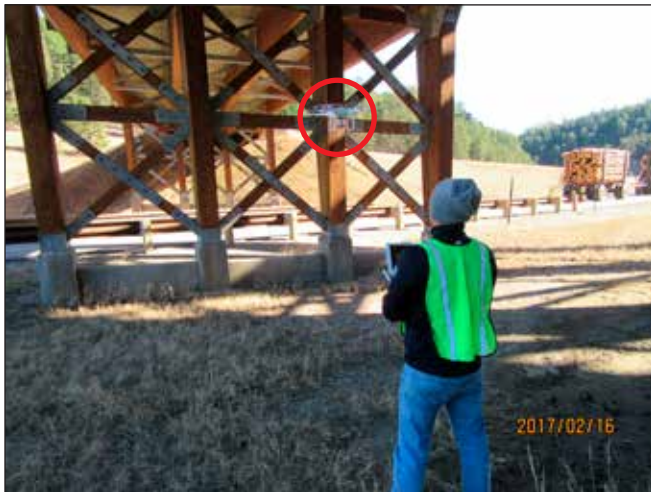
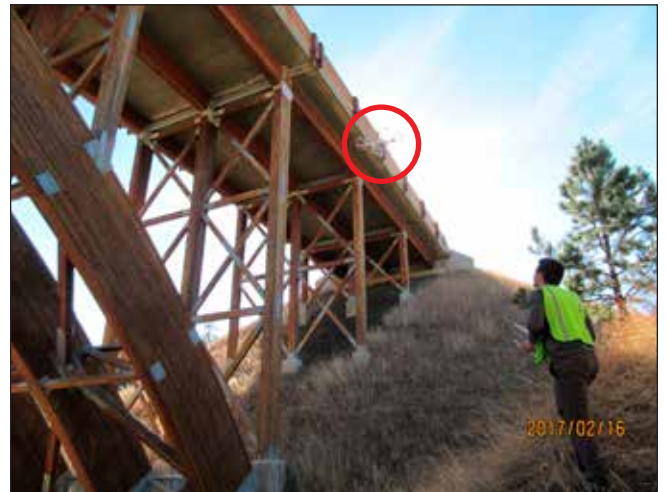
Figure 37. Sample images obtained from the full-scale bridge inspection on February 16th, 2017: (a) glulam girder; (b) glulam arch; (c) damage on timber girder bridge; (d) damage on joint of Keystone Wye arch bridge; (e) drone flying near column of timber girder bridge; (f) drone flying near column of Keystone Wye arch bridge.

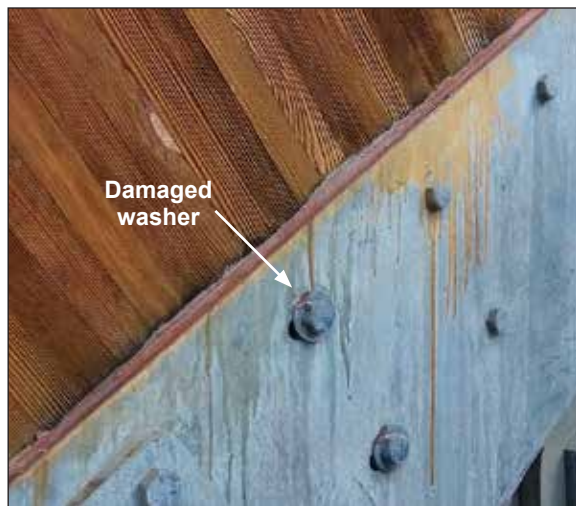
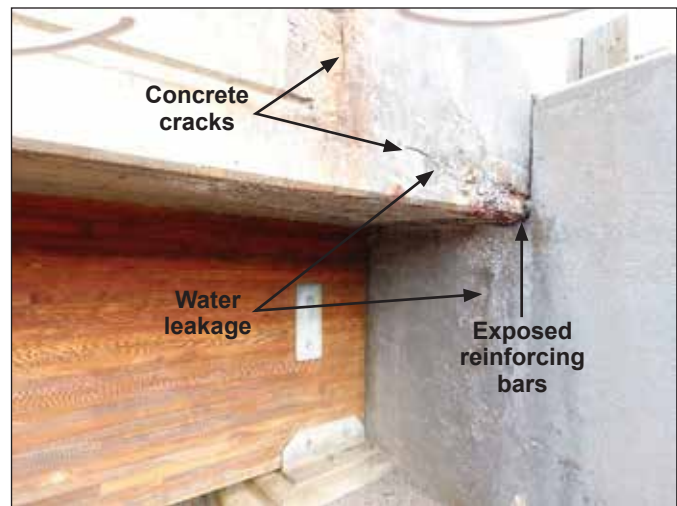
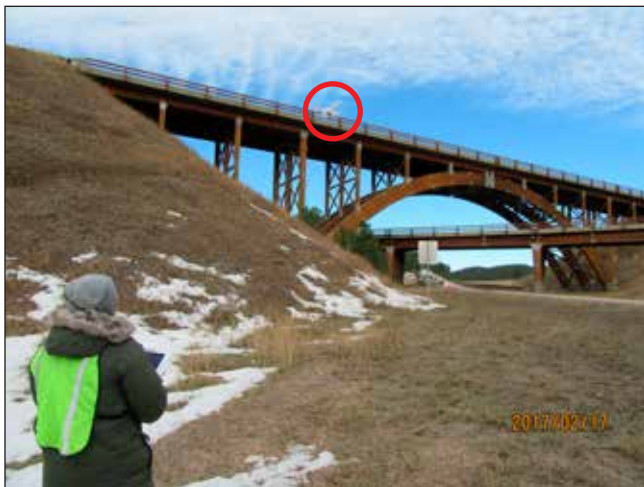
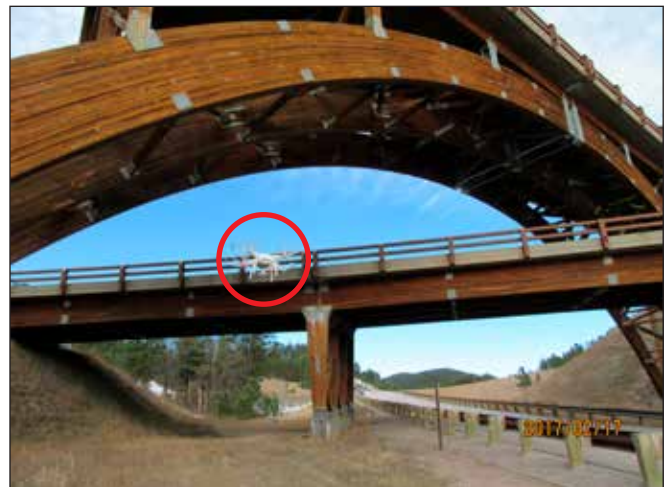
Figure 38. Sample images obtained from the full-scale bridge inspection on February 17th, 2017: (a) damaged washer near glulam arch support; (b) concrete cracking and water leakage at abutment location of timber girder bridge; (c) drone capturing overview of Keystone Wye arch bridge; (d) drone approaching timber girder bridge.

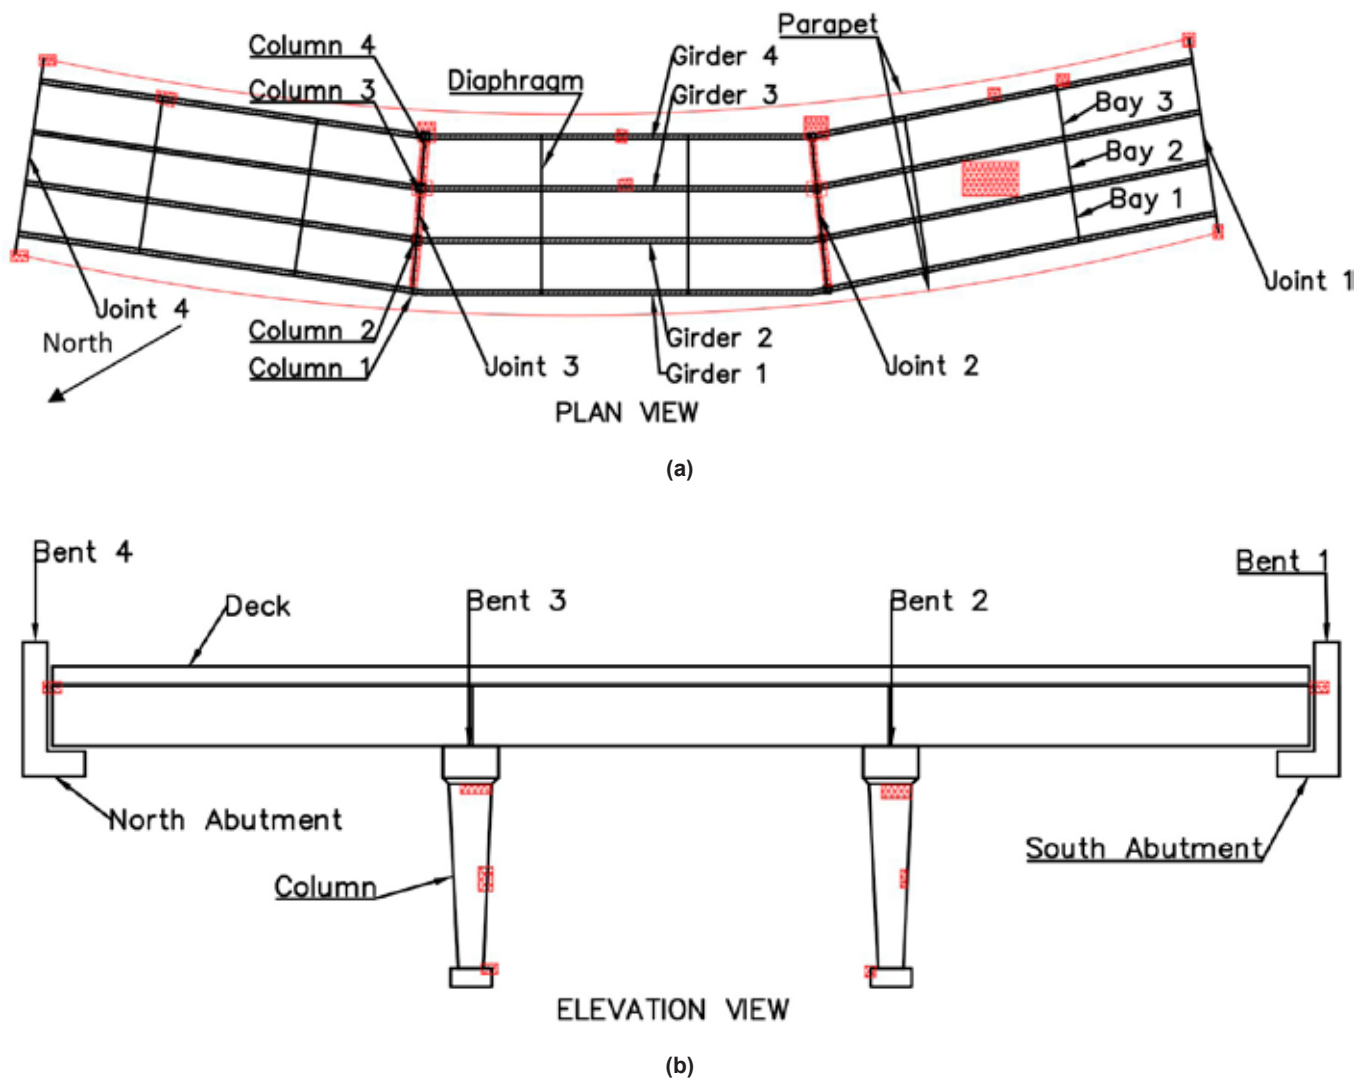
Figure 41. Timber girder bridge layout with identified damage: (a) damage on plan view; (b) damage on elevation view. (Red rectangles in plan and elevation views indicate damage, and red lines in plan view denote minor cracks along the parapet and rusting in railing in a longitudinal direction.)

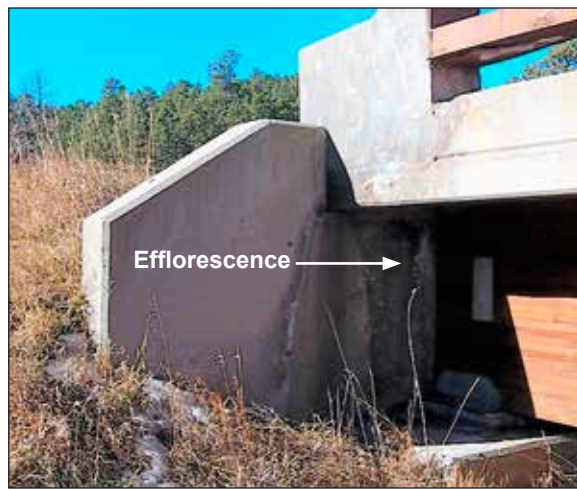
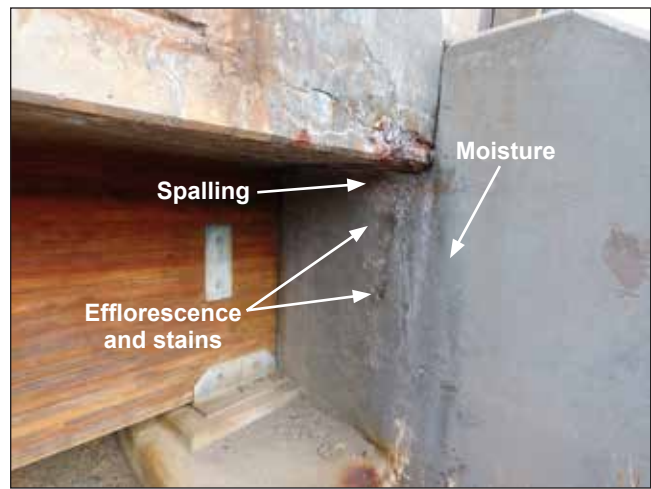
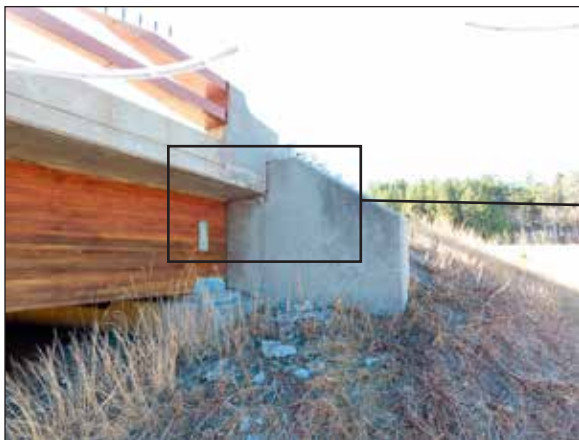
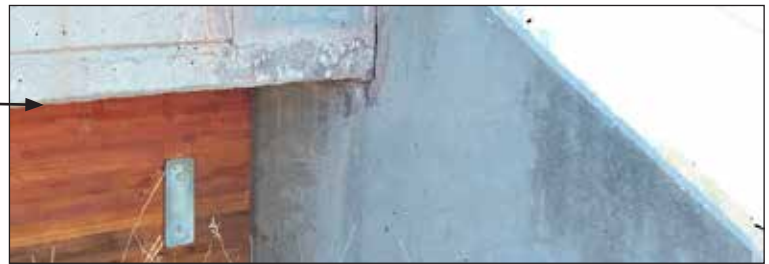
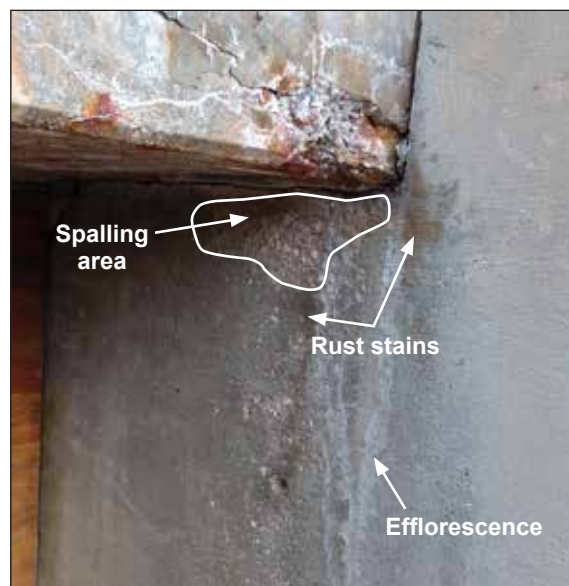
Figure 43. Abutment damage detected using drone: (a) efflorescence at south abutment near Girder 4; (b) spalling and discoloration of concrete caused by moisture at north abutment near Girder 4; (c) 3D virtual representation of south abutment near Girder 1; (d) quantified damage for north abutment near Girder 4.

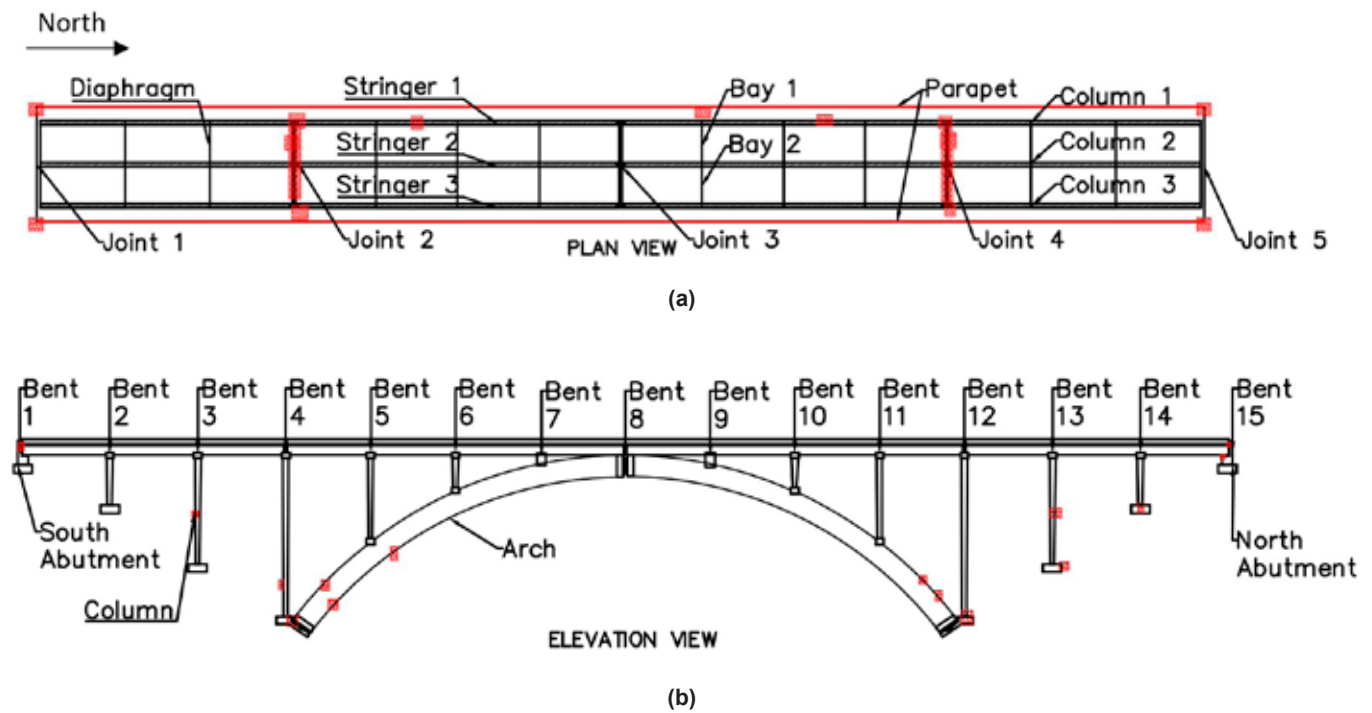
Plan and elevation views for the Keystone Wye bridge with damage found on each bridge component are presented in Figure 48a and b, respectively.

Figure 48. Keystone Wye bridge layout with identified damage: (a) damage on plan view; (b) damage on elevation view. (Red rectangles in plan and elevation views indicate damage, and red lines in plan view denote minor cracks along the parapet and rusting in railing in a longitudinal direction.)

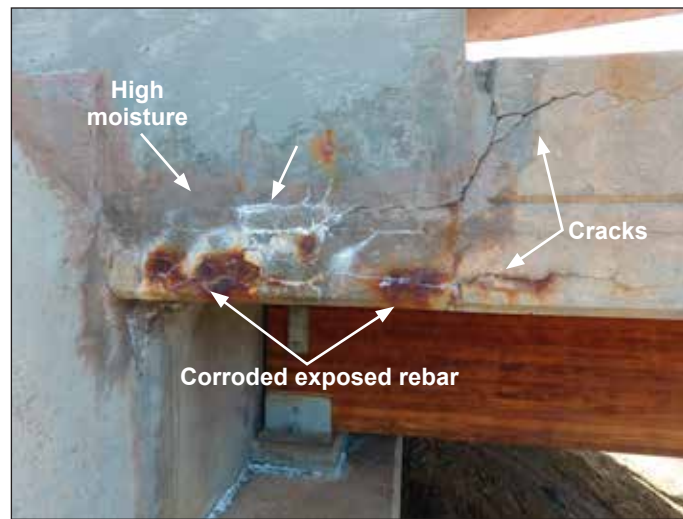
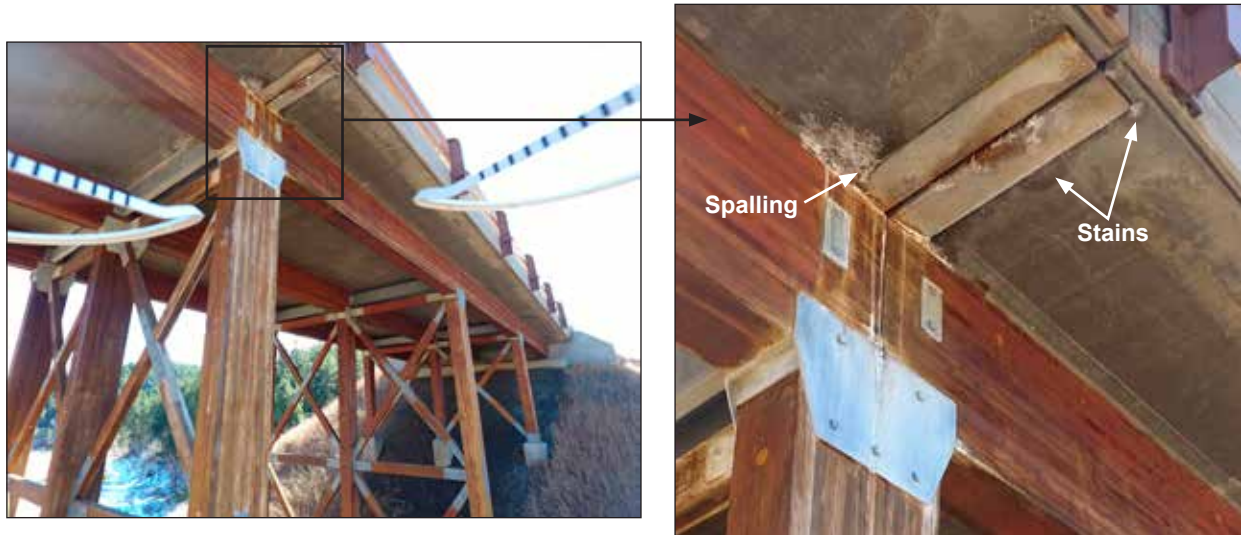
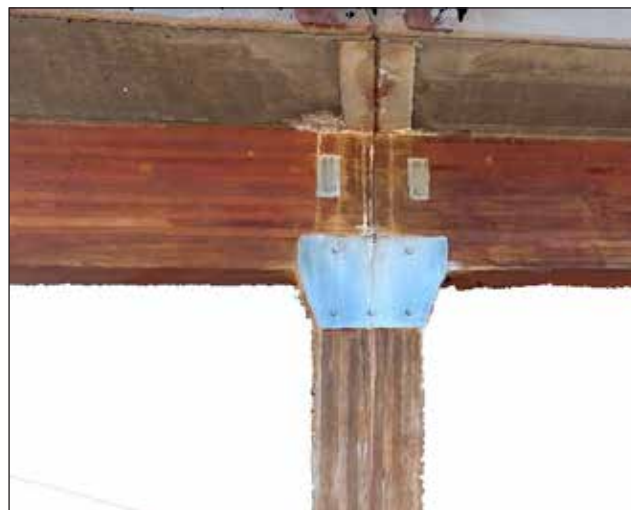
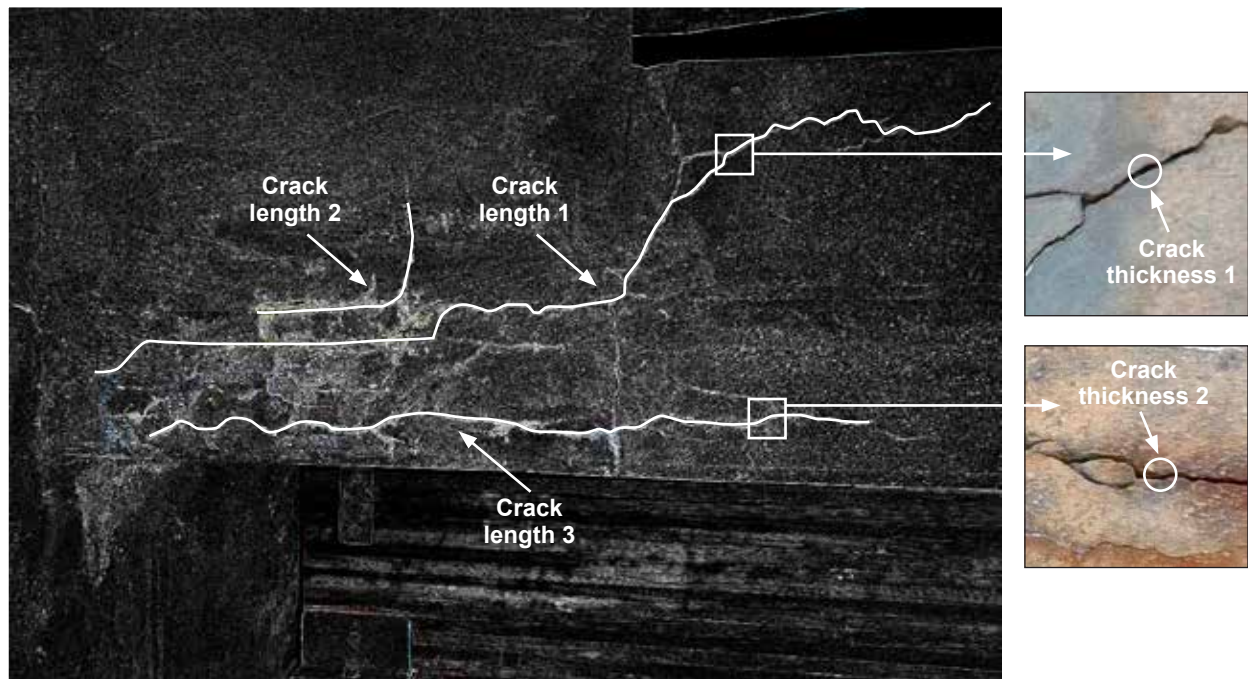
Figure 49. Deck damage identified using drone: (a) concrete cracks, stains, corroded exposed rebar, and moisture of deck near Stringer 1 at Joint 5; (b) concrete spalling and stains at Joint 2; (c) PhotoScan representation of Joint 2 damage; (d) edge detection using ImageJ to better visualize identified cracks and sample crack thicknesses; (e) identified corroded areas.

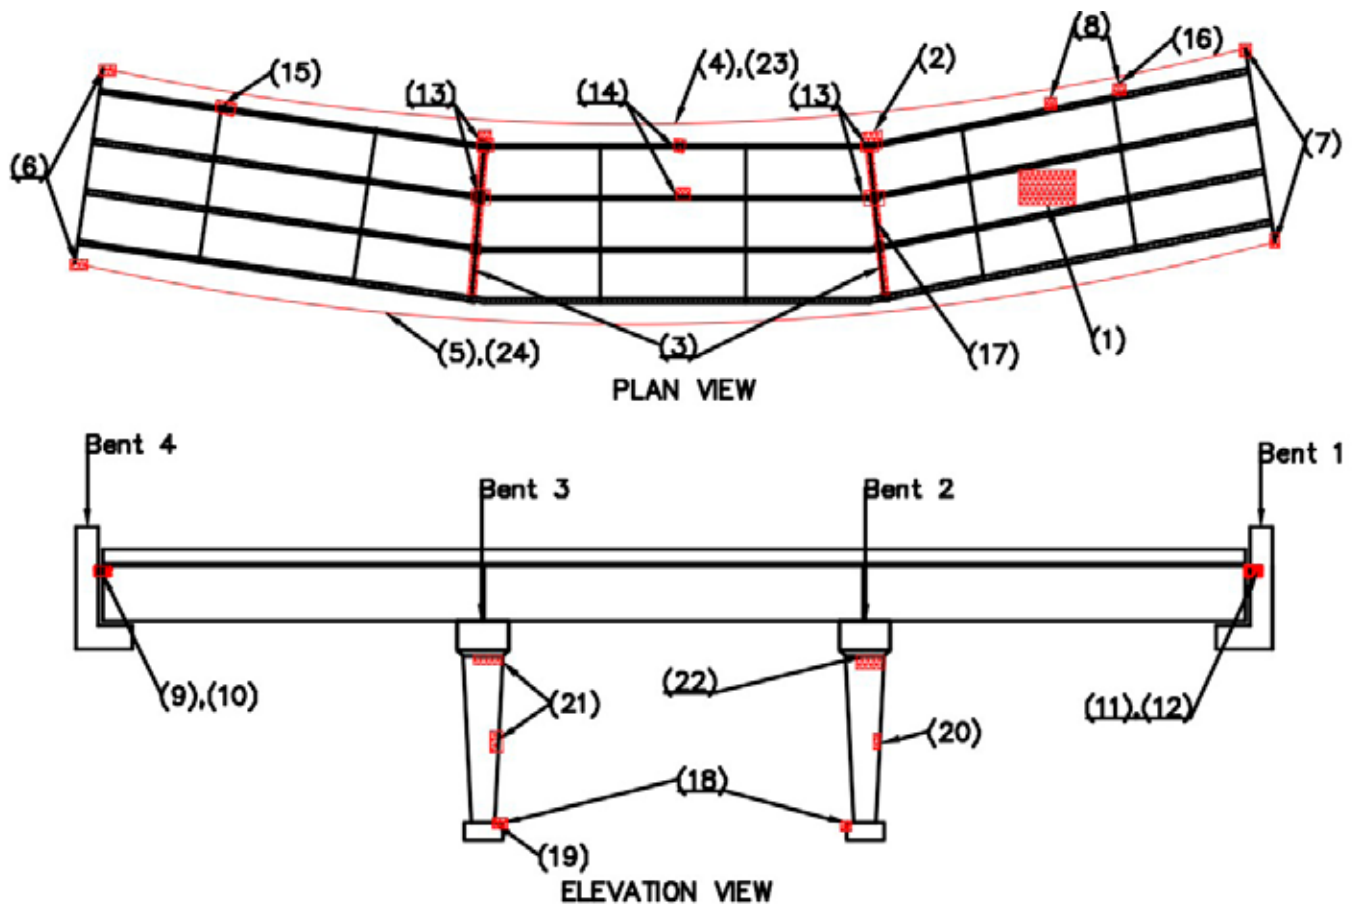
To efficiently compare damage identified from the drone-enabled bridge inspection and from the conventional SDDOT inspection, a schematic of damage identified by the drone is presented in Figure 56, and Table 23 summarizes damage side-by-side for each component. Table 23 shows that the damage identified by the drone is numbered from 1 to 24, and the corresponding numbers are also included in the layout in Figure 56 to show the location and for completeness of results.

^aNumbering of drone-enabled inspection report corresponds to damage location in Figure 56.^bN/A, not applicable.

Figure 56. Schematic of damage location on timber girder bridge. (Red rectangles in plan and elevation views indicate damage, and red lines in plan view denote minor cracks along the parapet and rusting in railing in a longitudinal direction. Numbering corresponds to damage summarized in Table 23.)

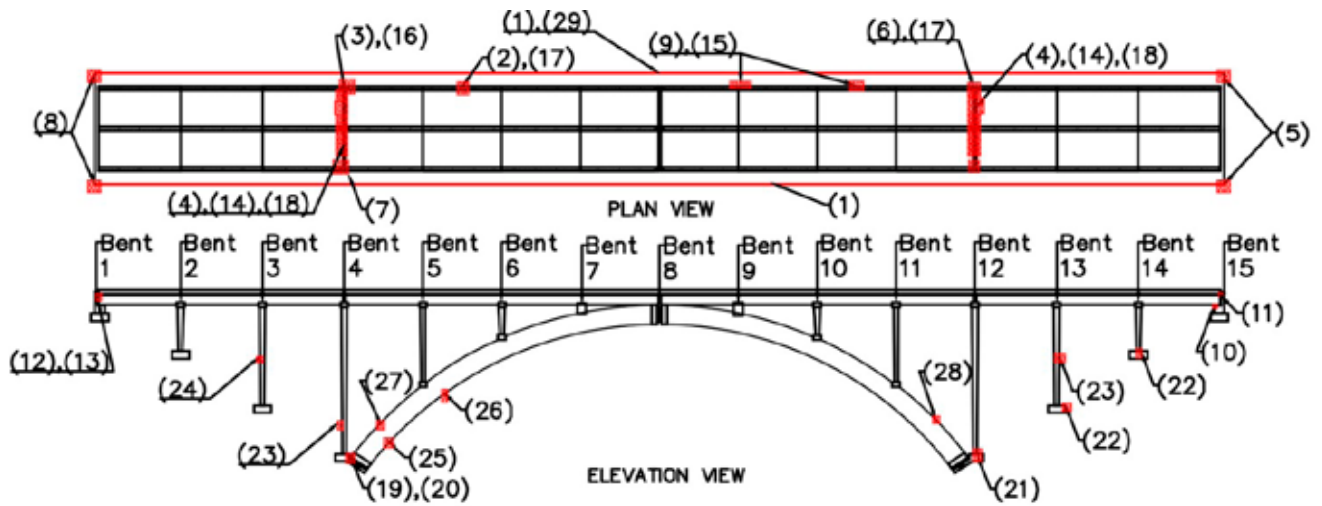
To compare damage identified from the drone-enabled bridge inspection and from the conventional SDDOT inspection in an efficient way, a schematic of damage identified by the drone is presented in Figure 63 and side-by-side damage for each component is summarized in Table 24. Table 24 numbers the damage identified by the drone from 1 to 29, and corresponding numbers are shown in Figure 63 to show the location of the damage and for completeness of results.

^aNumbering of drone-enabled inspection report corresponds to location in Figure 63.^bN/A, not applicable.

Figure 63. Damage location on Keystone Wye arch bridge. (Red rectangles in plan and elevation views indicate damage, and red lines in plan view denote minor cracks along the parapet and rusting in railing in a longitudinal direction. Numbering corresponds to damage summarized in Table 24.)

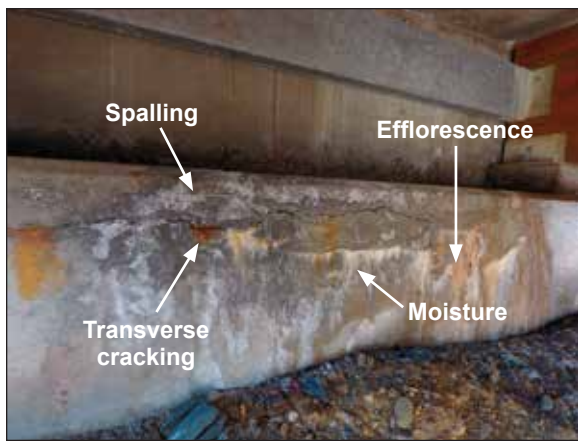
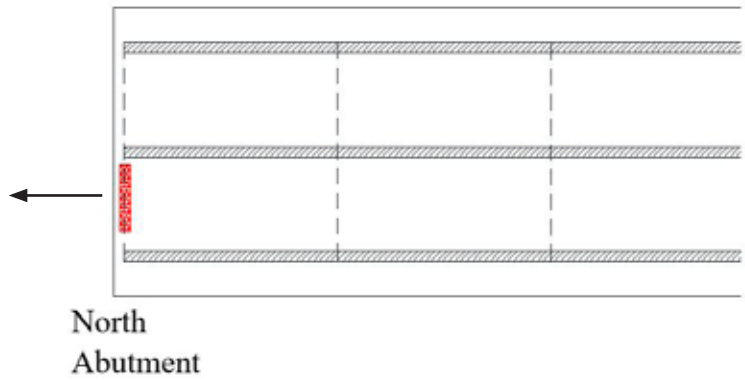
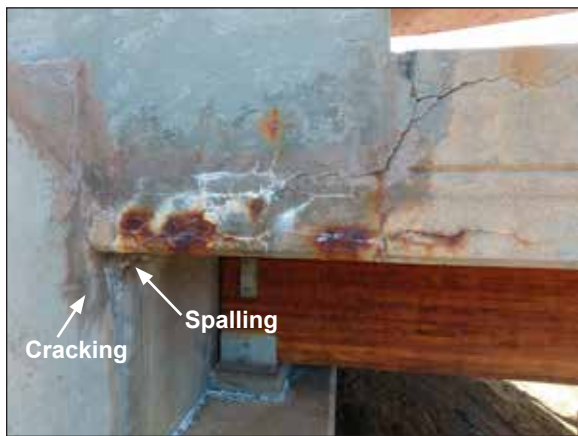
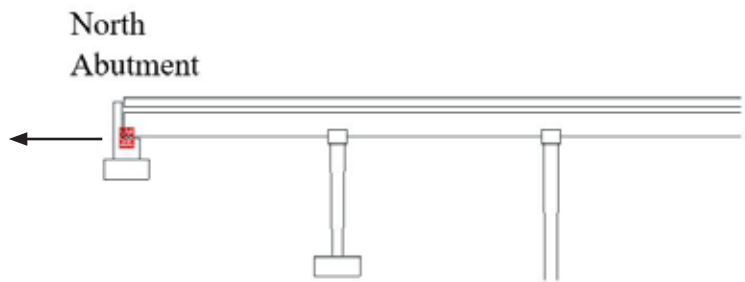
Most of the abutment damage reported by SDDOT was observed using the drone. The areas of damage identified using the drone are for the sections near Stringers 1 and 3 of the abutments because these sections were open for the drone to approach. Some critical damage such as a transverse concrete crack, spalling, moisture, and efflorescence at the north abutment on Bay 1 was captured (Fig. 65a). Figure 65b shows abutment cracking and spalling at the north abutment. The identified sample damage locations are included in the schematic of the partial bridge plan (Fig. 65c). Images associated with the abutment damage were not available from SDDOT for comparison purposes.

Figure 65. Sample damage on north abutment: (a) transverse concrete crack, spalling, efflorescence, and moisture on Bay 1; (b) damage location on plan view; (c) concrete cracking and spalling near Stringer 1; (d) damage location in elevation view.
